Errata Sheet for

Advisory Circular 150/5340-30D, Design Installation Details for Airport Visual Aids

Last Update: March 6, 2009

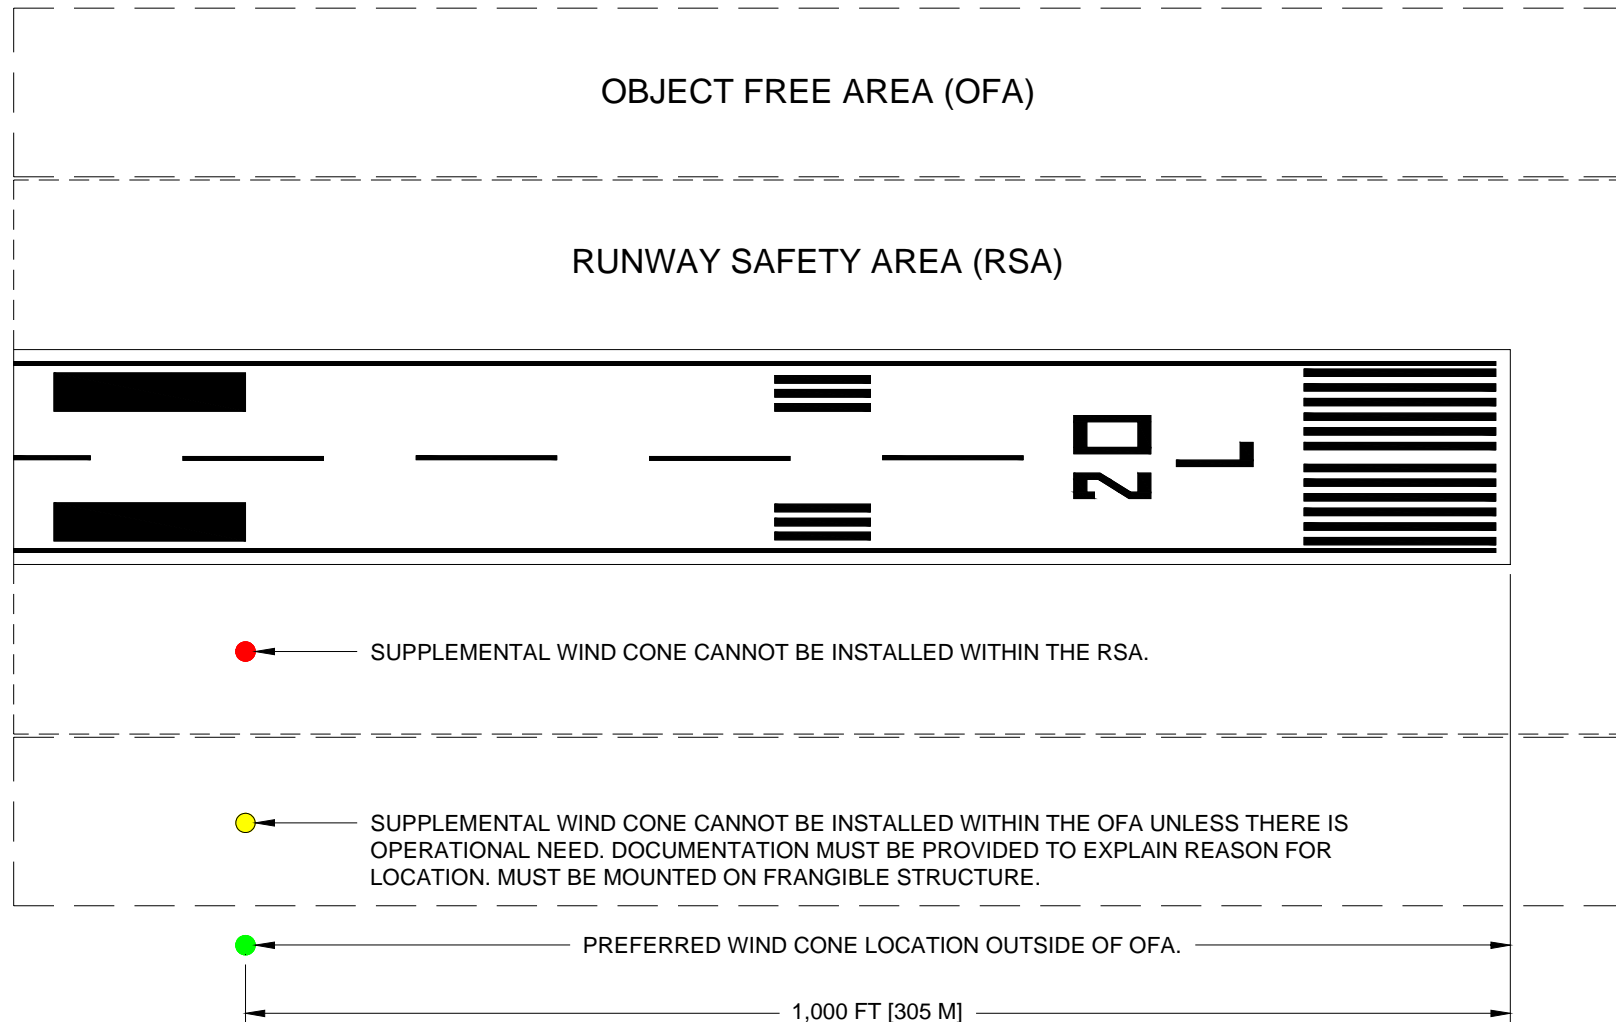
#	Description of Correction	Location	Rationale	Date Error Corrected
1	Add the following after the 3 rd sentence in paragraph 6.3.c: "See Figures 131 and 132 for installation details."	Page 45 (Replace pp. 45-47)	Needed clarification to ensure readers understood standards are applied to primary wind cone.	03/06/09
2	Add the following at the end of paragraph 6.3.c: "See Figures 74 and 75 for installation details on supplemental wind cones."	Page 45 (Replace pp. 45-47)	Needed clarification to ensure readers understood the standards are applied to supplemental wind cone.	03/06/09
3	Replace Figure 74, "Typical Location of Supplemental Wind Cone", with the revised figure (included below).	Page 186	Figure 74 corrected so it is consistent with the standards addressed in section 6.3.	03/06/09
